Mekong Delta Living Lab Project

An Open-Air Laboratory for Coastal Protection and
Nature-based Solution

Annual Report

Vietnam, December 2024

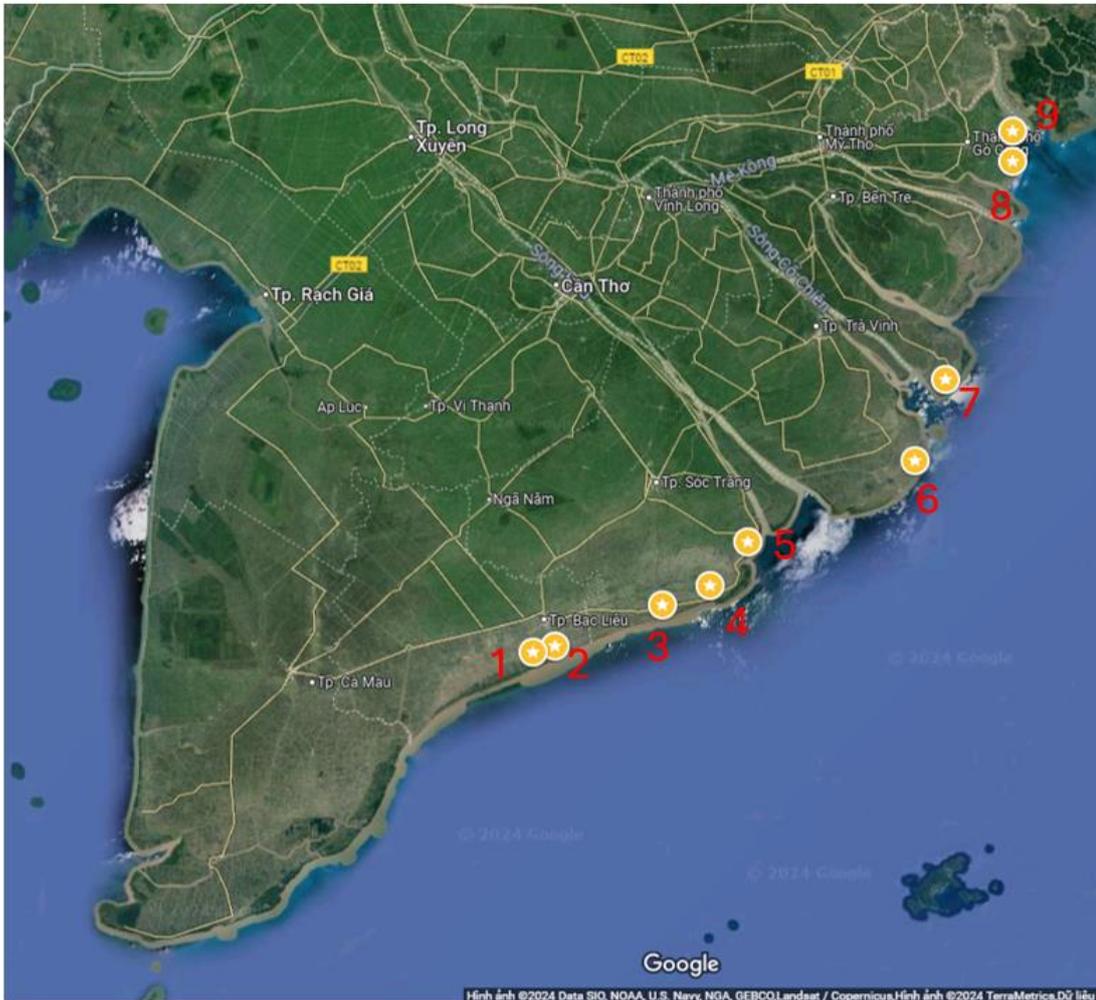
Figure 9. The visited locations during the Mekong Delta Trip on 6-9 September 2024

The list of visited locations are shown in Table 1:

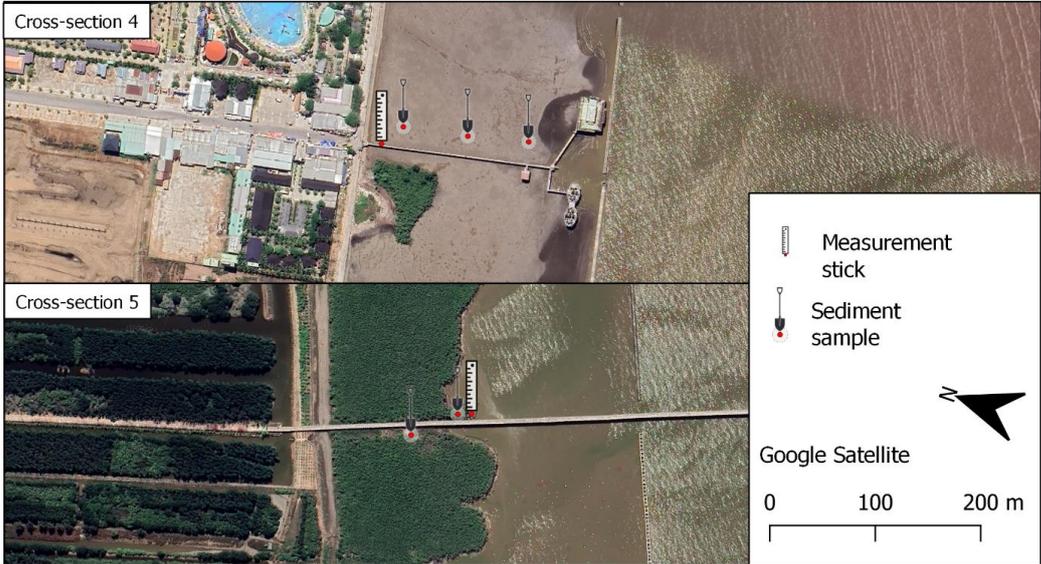
Soil & Inundation

Location	Sample	Sand [%]	Silt [%]	Clay [%]	D ₅₀ [mm]
Cross-Section 4 Nha Mat	NM1	17.8	60.3	21.9	0.0252
	NM2	14.3	62.2	23.5	0.0232
	NM3	23.8	54.3	22.0	0.0273
Cross-Section 5 Hoa Binh	M1	3.5	52.6	43.8	0.0070
	M2	2.0	53.5	44.4	0.0070
	M3	21.9	69.7	8.3	0.0345
	M4	98.1	1.4	0.5	0.1750
