Annual Field campaign Report

Mekong Delta Living Lab – An Open-air Laboratory for coastal protection and nature-based solutions

Vietnam, 2024

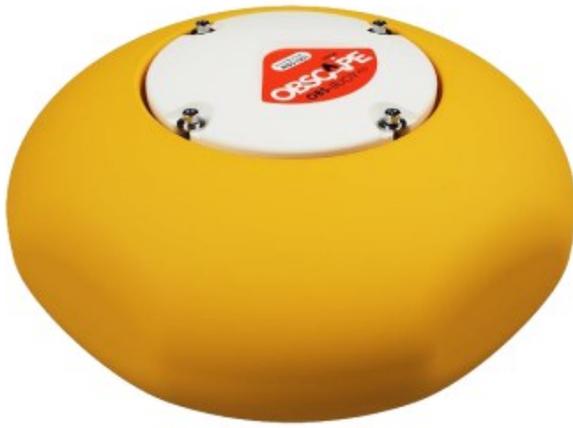
(a) Wave bouy: OBS-Buoy 400

(b) Weather station

(c) Time-lapse camera

(d) Pressure-based wave gauge

(e) Level gauge Radar

Figure 3. Obscape devices.

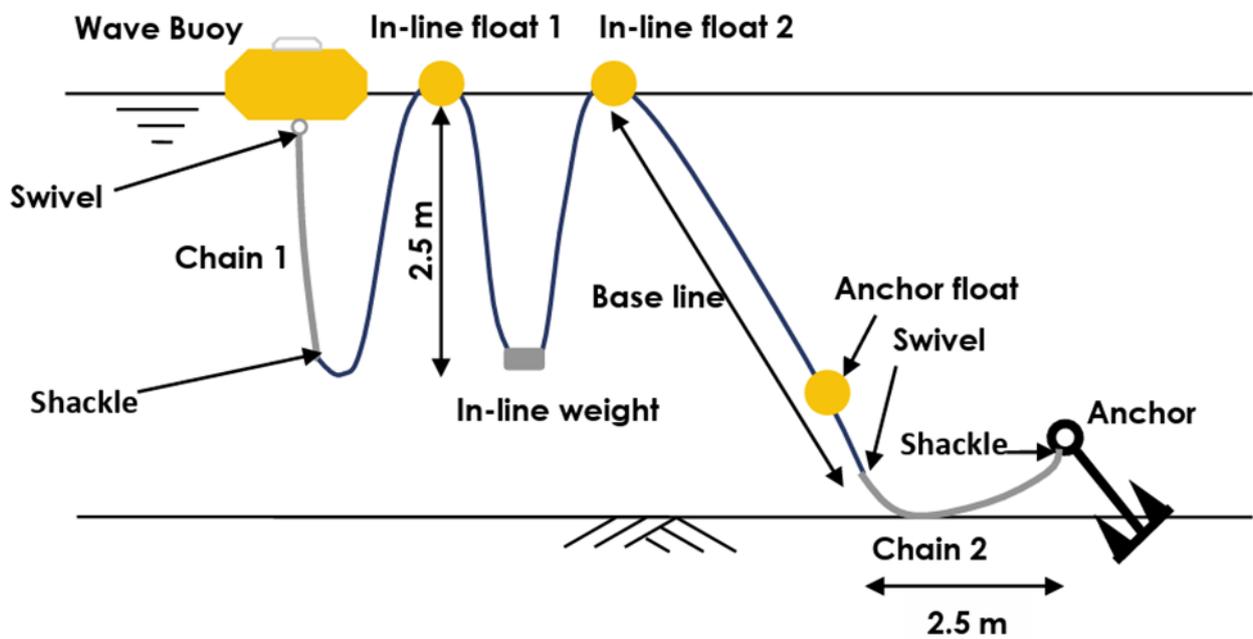
Figure 4. Measurement scheme of Wave buoy.

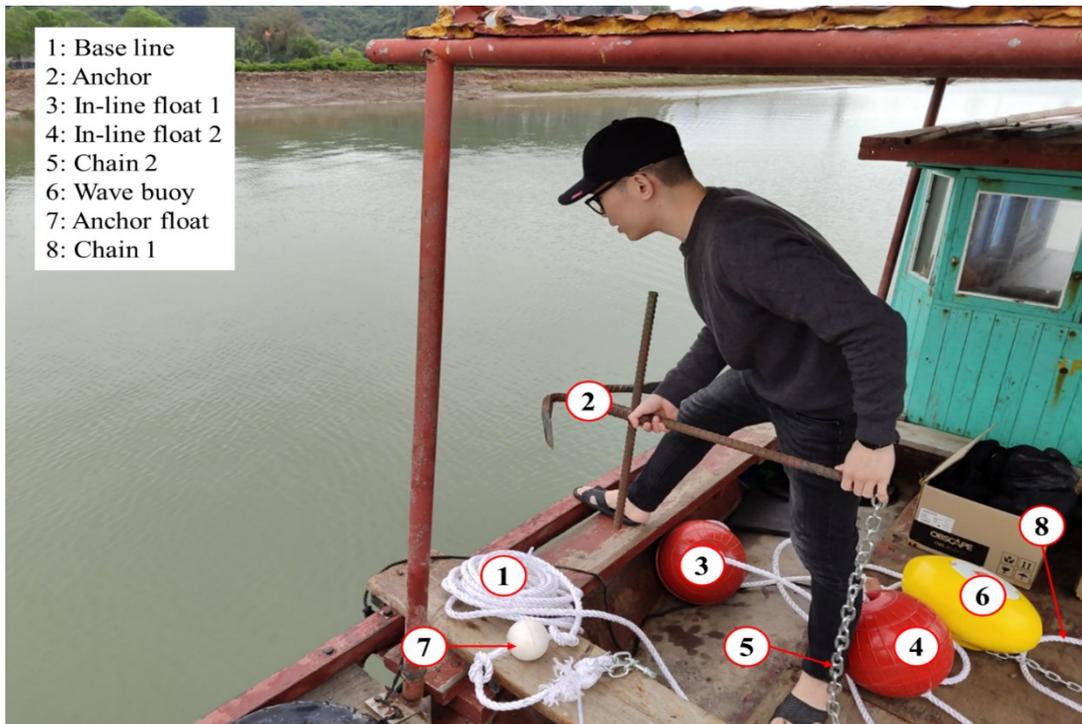
Figure 5. Wave buoy installation processes.

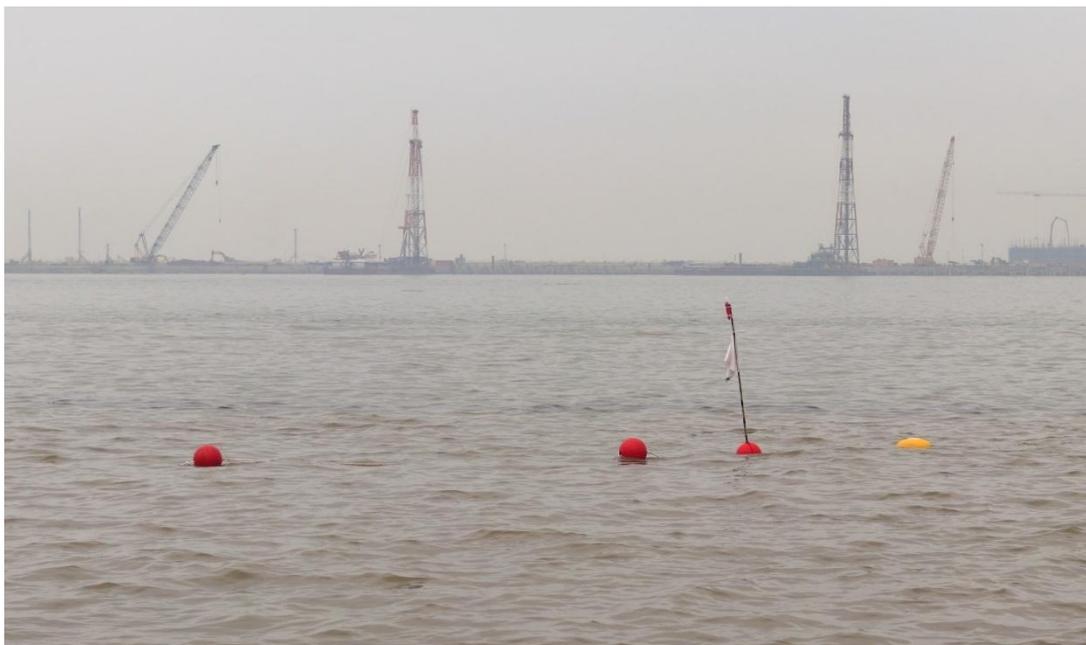
Figure 6. Wave bouy system after installing. Two red balls on the left side are the in-line floating connected with easy-spot objects (flags and lights). The yellow spot on the right is the wave bouy. This system can work up to 12 months under normal conditions.

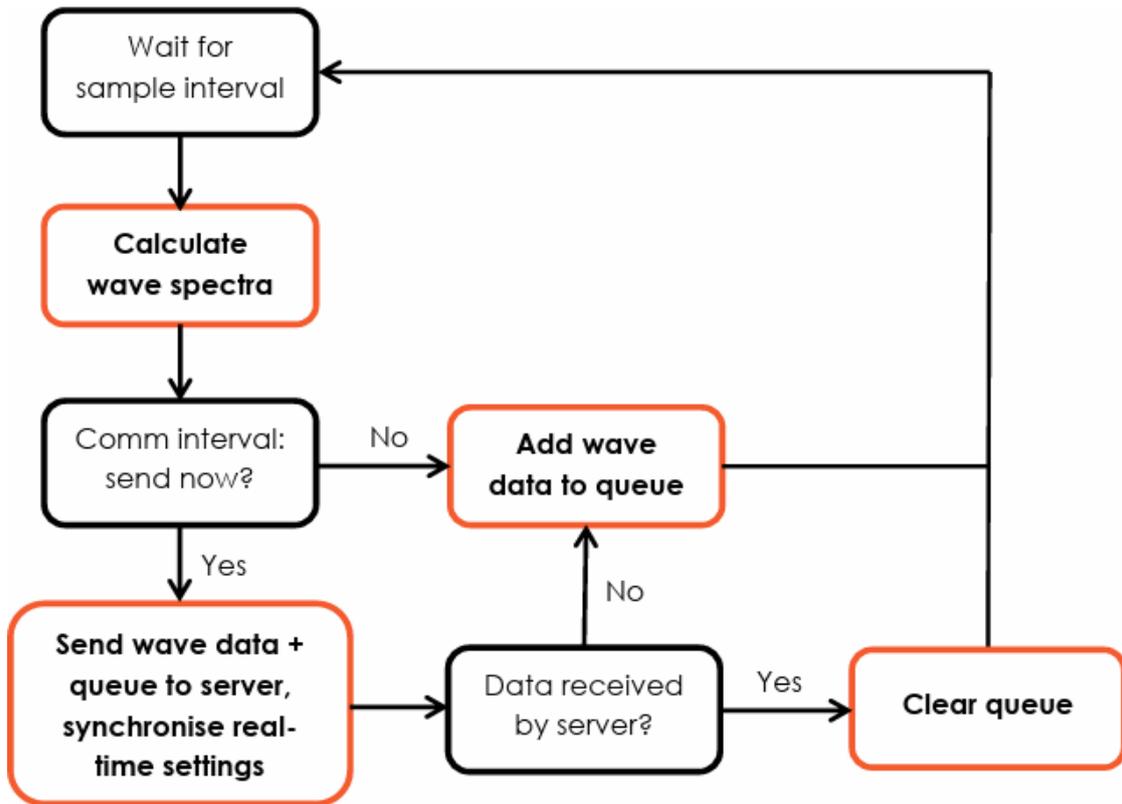
Figure 7. Measurement and telemetry cycle during the campaign.

In the field, wave bouy is vulnerable under strong wave conditions, so it should be observed and have daily checking during the measurement campaign. The team checks the bouy every 03 hours. The ideal time should be 7, 10, 13, 16, 19, and 21 hours, including several aspects, such as the general information, abnormal functions, data streaming portal, and device location. Figure 7 below shows the daily measurement and telemetry cycle.

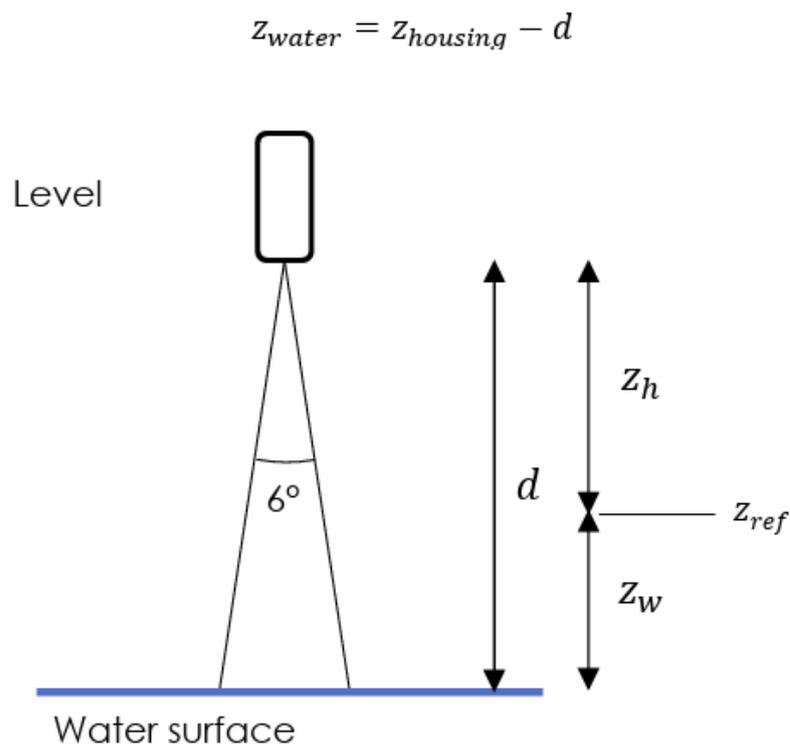
Figure 8. Level gauge radar principle.

Level gauges use the method below, where d is the distance between the sensor and the water surface.

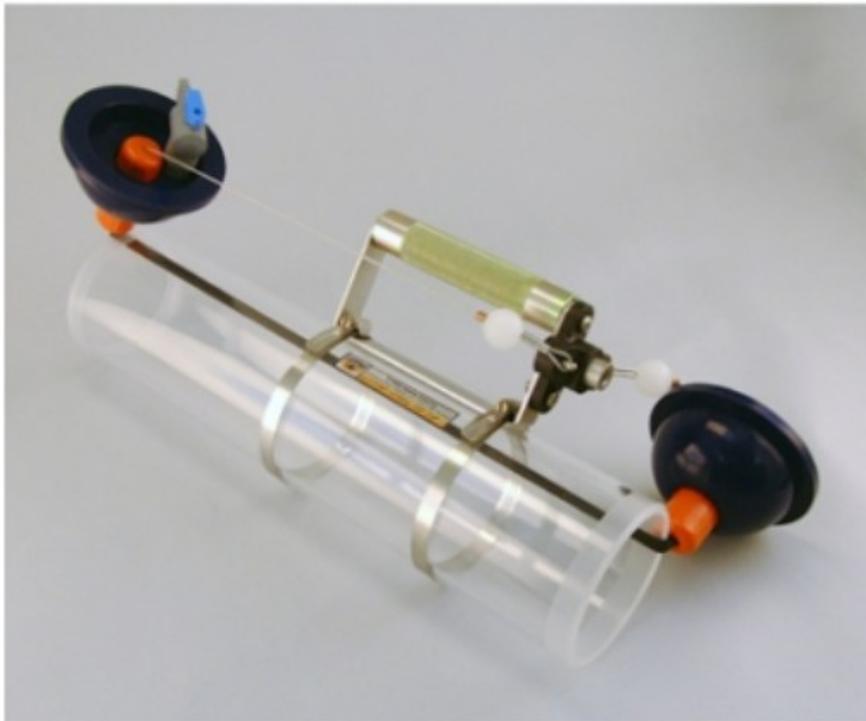
Figure 9. Sedimentation/Water quality collection toolkit

Sedimentation data is collected within the frequency of 3 times per day at the current/flow or wave stations. Collecting toolkits include a 40-60cm diameter tube (See Figure 4) being collected at different depths by ropes. An ideal volume for each collecting time is designed by the supporters with metadata written, e.g., location, date and time.

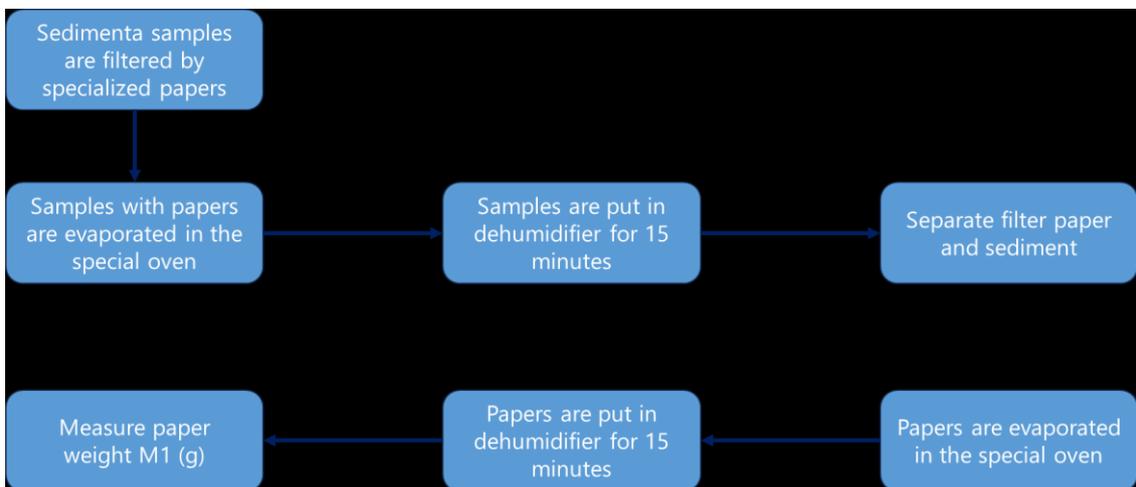
Figure 10. Analyzed processes for sedimentation

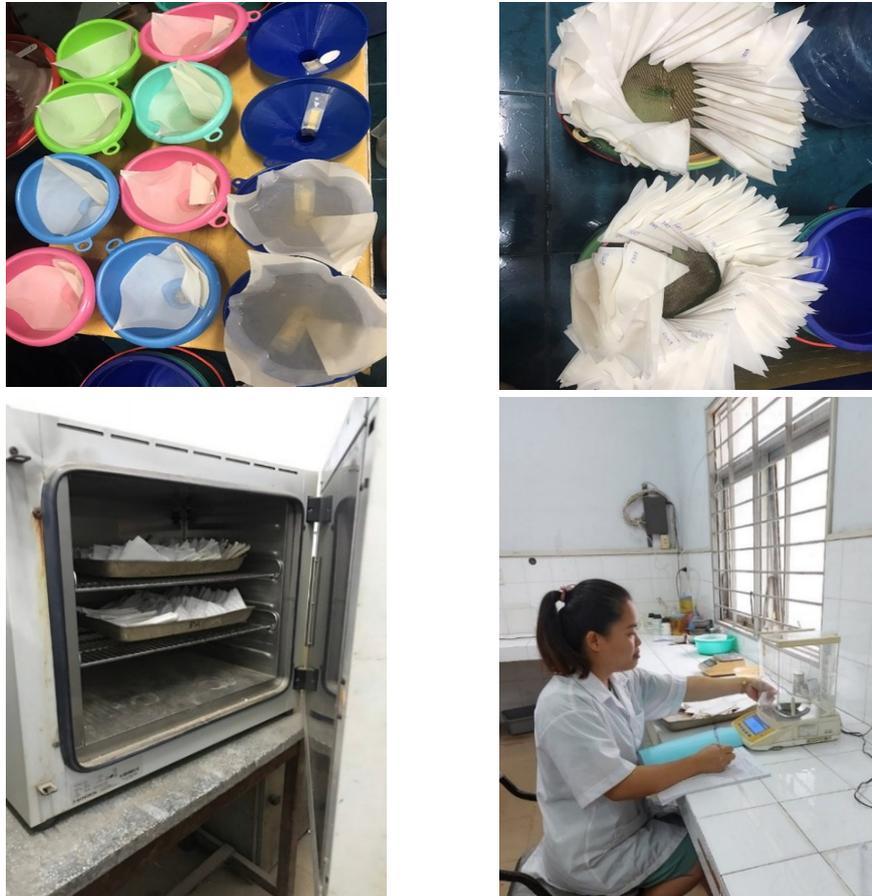
Figure 11. Examples of Sedimentation analyzed processes. Filter papers (Upper left and right panels), dried processes (Lower left panel), and weigh the filter paper with sediment (Lower right panel).

The sedimentation samples, including the filtered papers, are then brought to be measured the secondary weights. The final result will be written in the field notes.

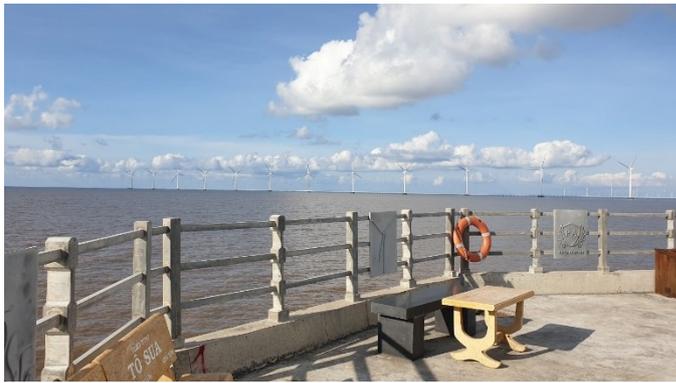
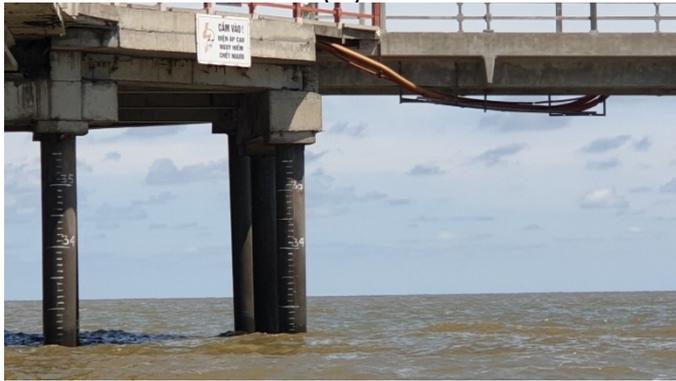
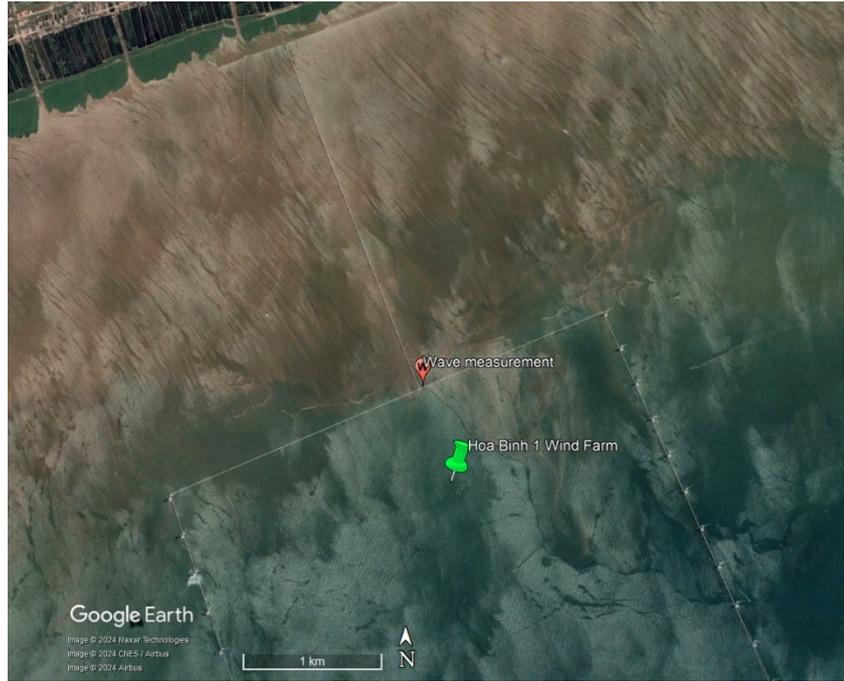
Figure 13. Measured location in Hoa Binh 1. (a) pier and (b) poles at the pier; (c) Location on map.

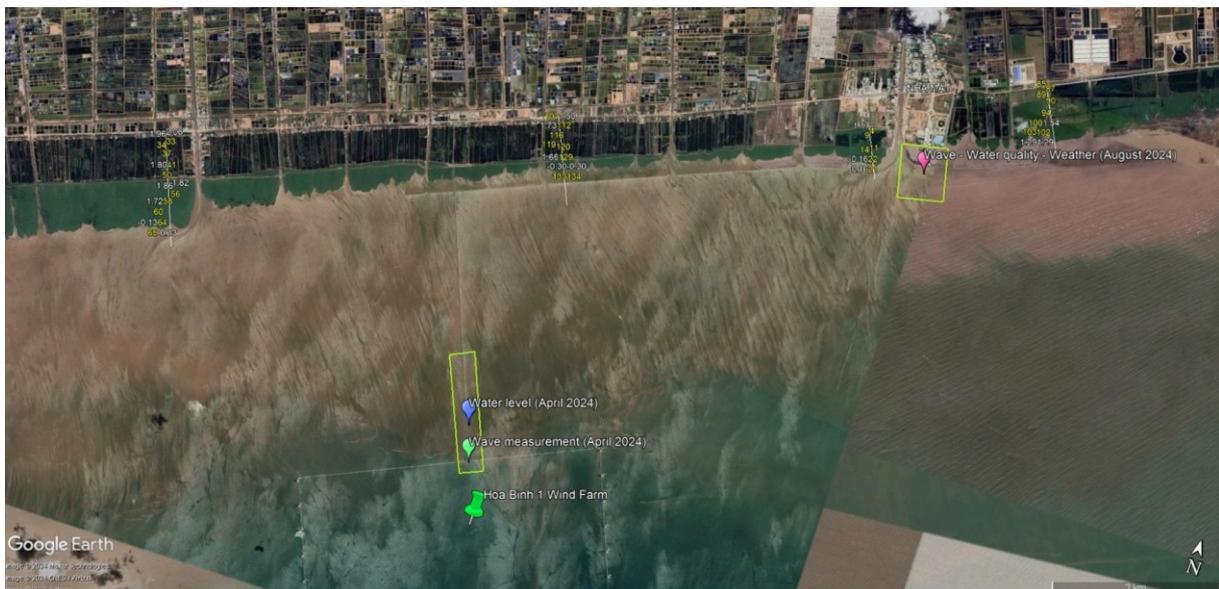
Figure 14. Location of device installation in April and August 2024

The team set the Level gauge and pressure-based wave gauges at the locations presented below.

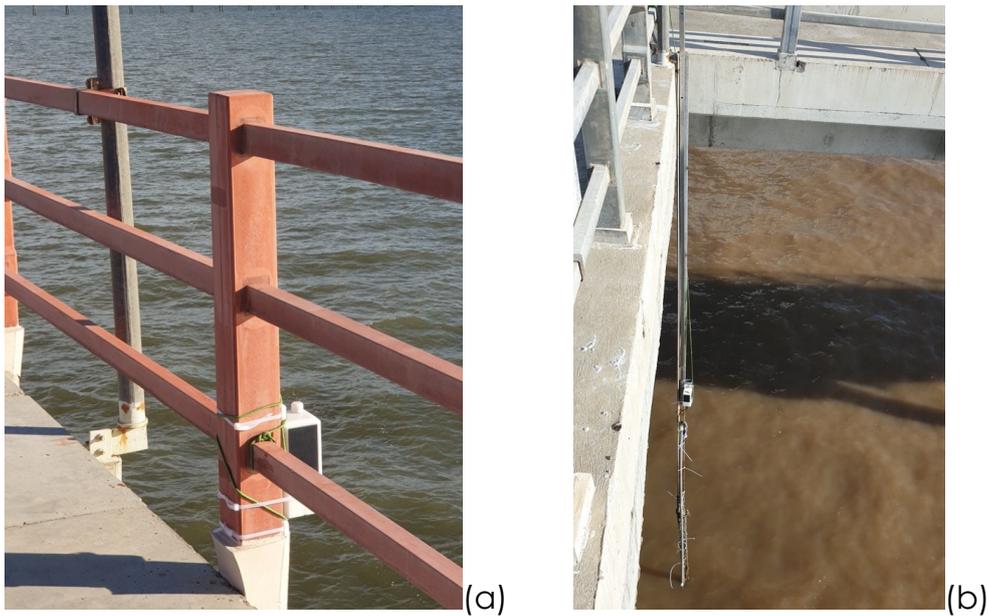
Figure 15. The level gauge for water level (a) and the Pressure-based wave gauge (b) were installed at the location presented in Figure 14.

-/ Water level and wave measurement. The devices are the Level gauge and Pressure-based wave gauge (see Table 1) and are shown below:

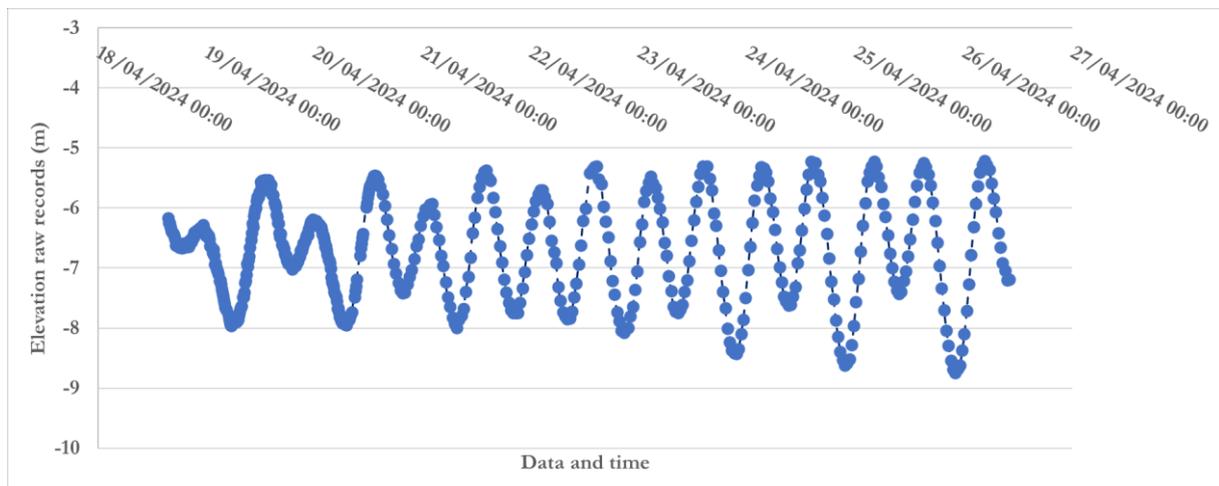
Figure 16. Elevation of raw records from the Level Gauge

The data captured from the two devices are presented with elevation raw level (Figure 16), significant wave heights (Figure 17), and mean wave period (Figure 18).

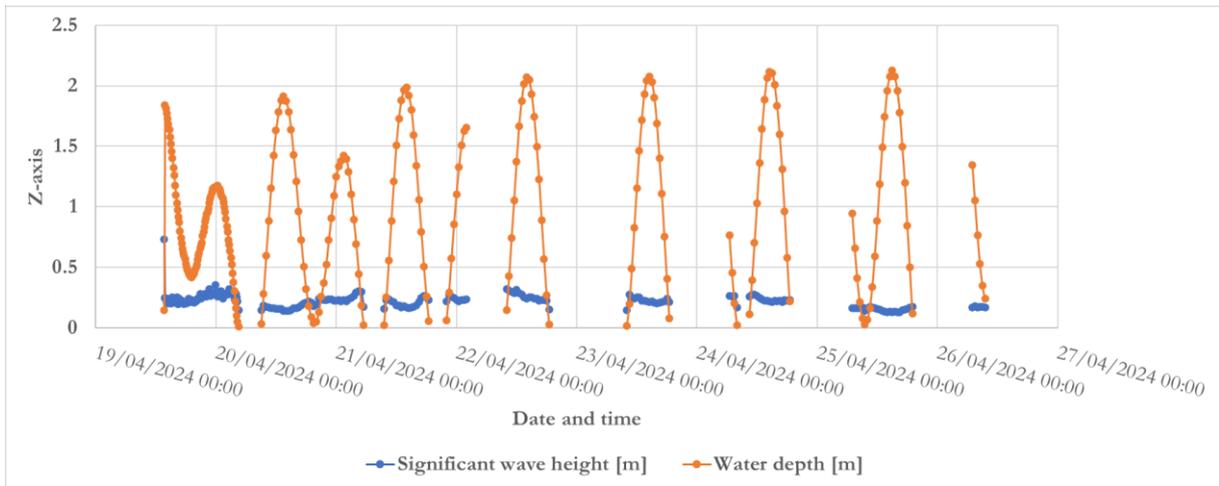
Figure 17. Significant wave height from pressure-based wave gauge.

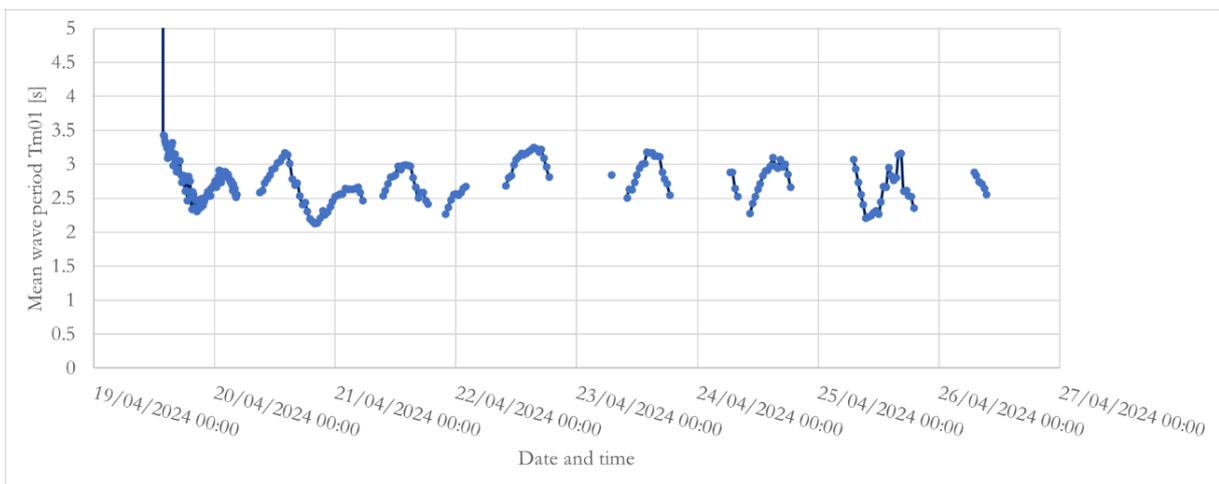
Figure 18. Mean wave period from pressure-based wave gauge.

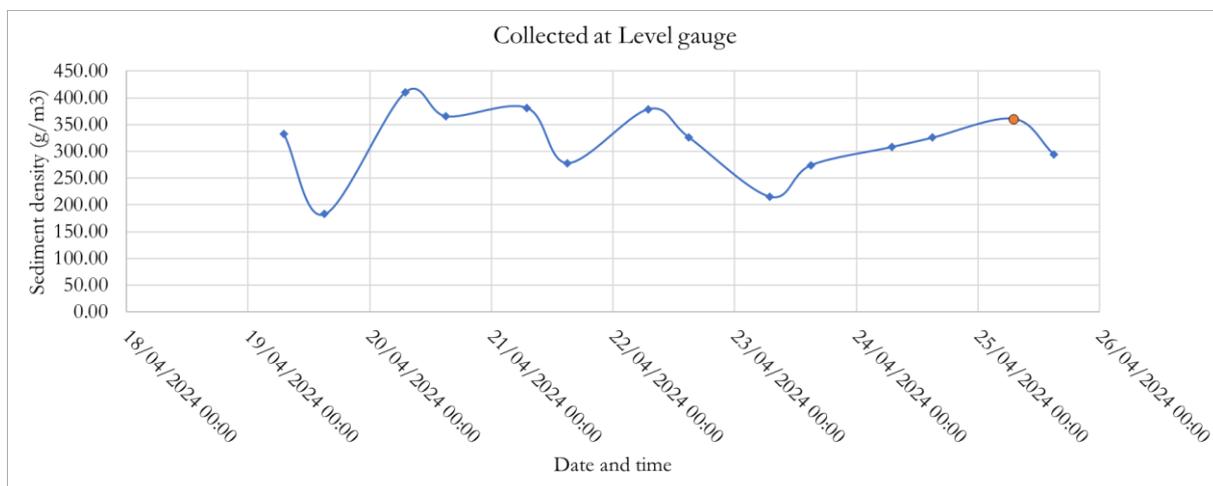
Figure 19. Sedimentation changes over time at the Level Gauge location

Sedimentation samples are collected twice a day, at 7 and 15 hours, and at two locations. Hence, there are four samples in a day from 24 to 26 April 2024. After all samples are collected in the field, they will be dried and measured again in the laboratory. The results are presented below:

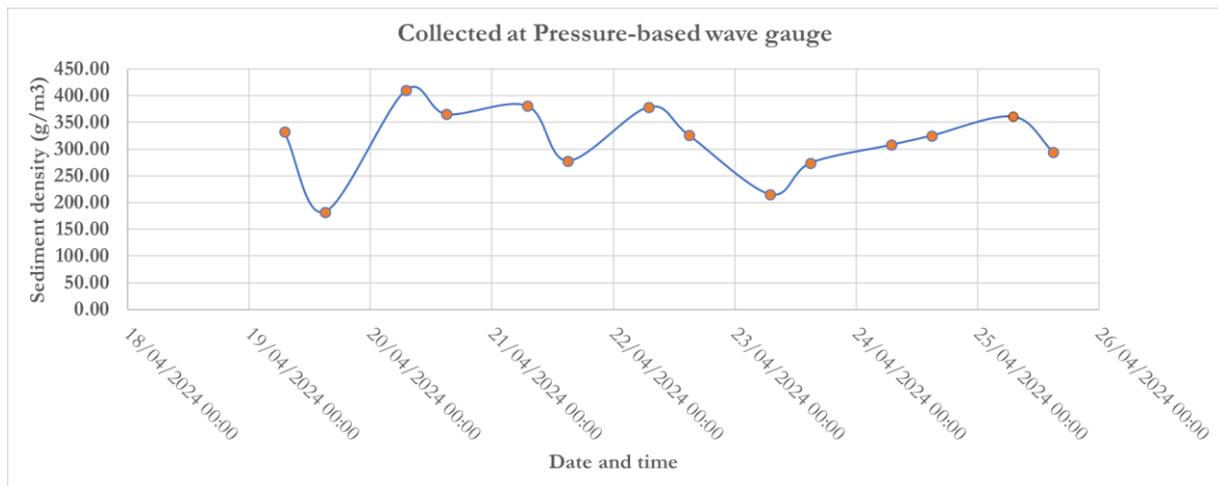
Figure 20. Sedimentation change over time at Pressure-based wave gauge location

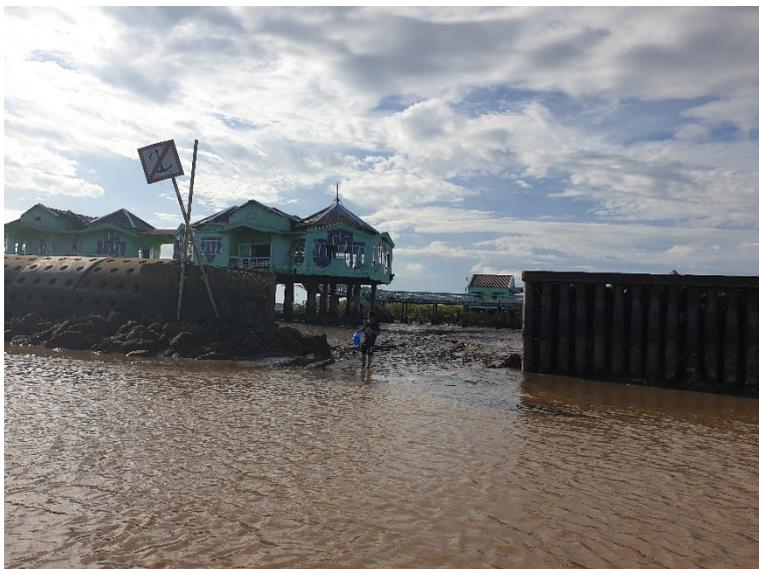
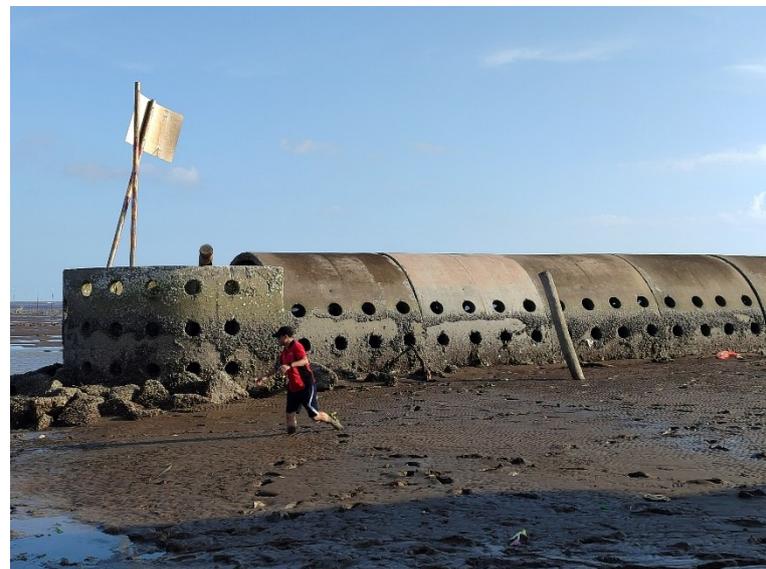
Figure 23. (a) the Hollow pile rocks dike is on the right side of the Hollow pie dike, and (b) the circle porous dike.

In the meantime, the team visited several infrastructures, such as the Hollow Pie Dike (Figure 23), the Hollow Pile Rocks Dike (Figure 24), the left and the right side of the bridge to Nha Mat restaurants (Figure 25), and finally discussed on the standards of the living lab location (Figure 26b). The team also paid respects to the farmer, who was willing to help the team install the devices in his tent (Figure 26a).

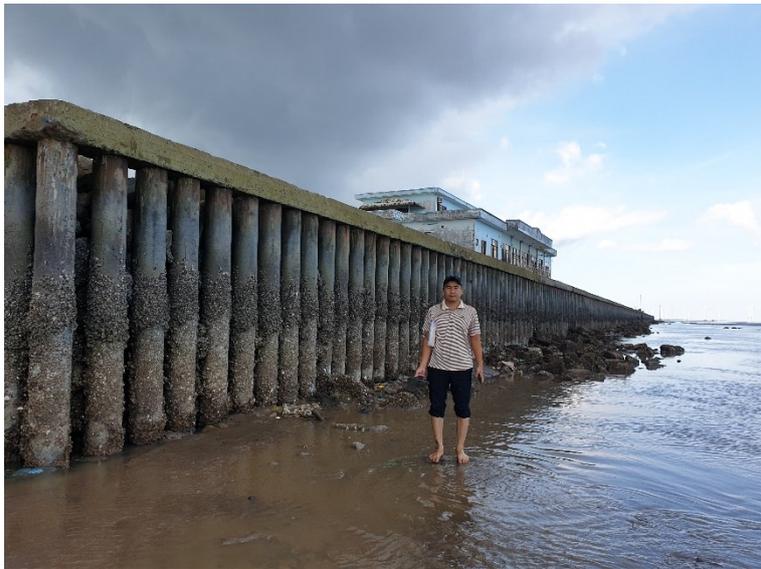
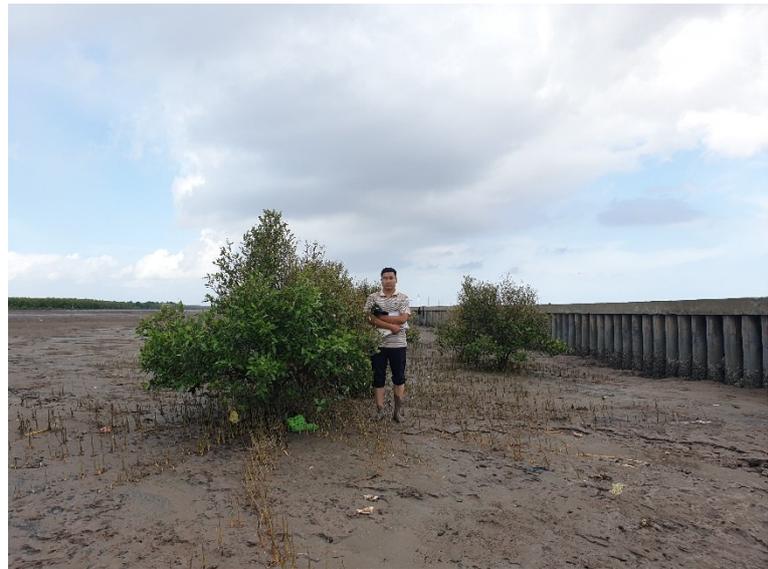
Figure 24. The hollow pile rocks dike at the seaside (a) and at the land side (b). Natural mangroves can survive behind the dike due to an increase of sedimentation and high bed elevation enough for mangrove surviving.

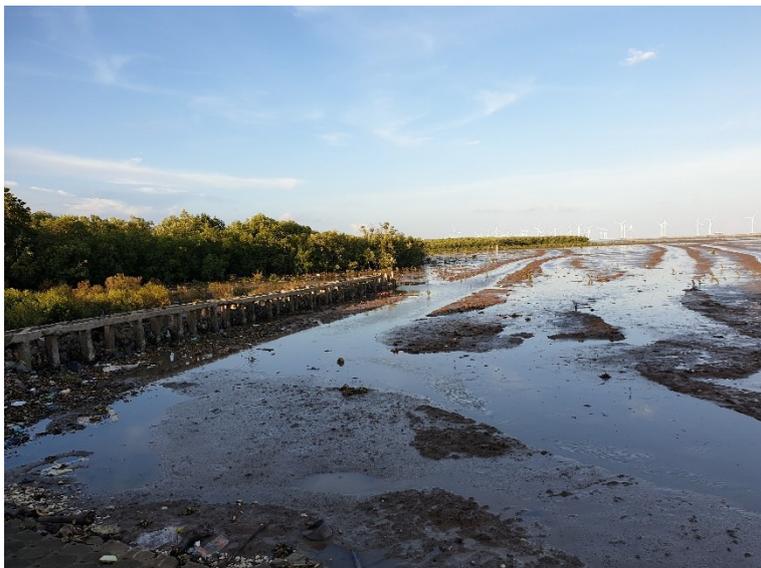
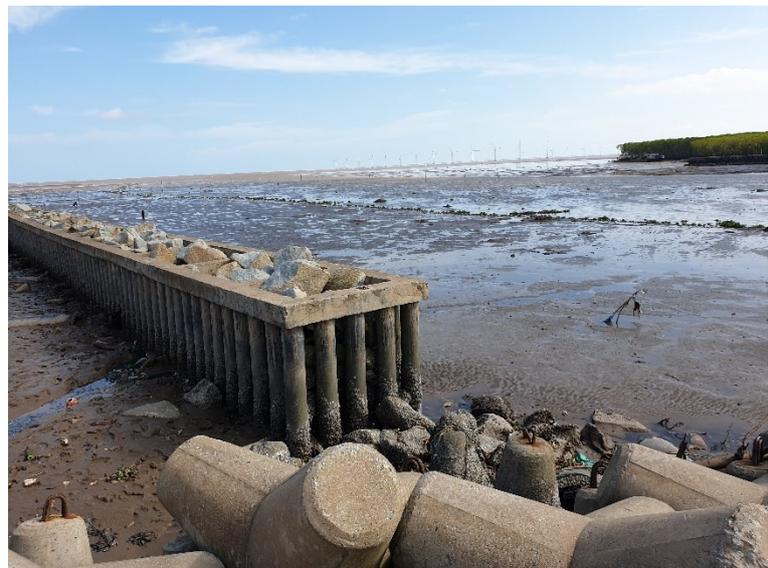
Figure 25. (a) The left side of the bridge to Nha Mat restaurants. Senior and young mangroves behind the piers. This area has been left out due to several failed projects. (b) The right side of the bridge to Nha Mat restaurants. This area is close to the river mouth and protected by Hollow Pile Rocks Dikes, and the Tetrapod at the dike slope.

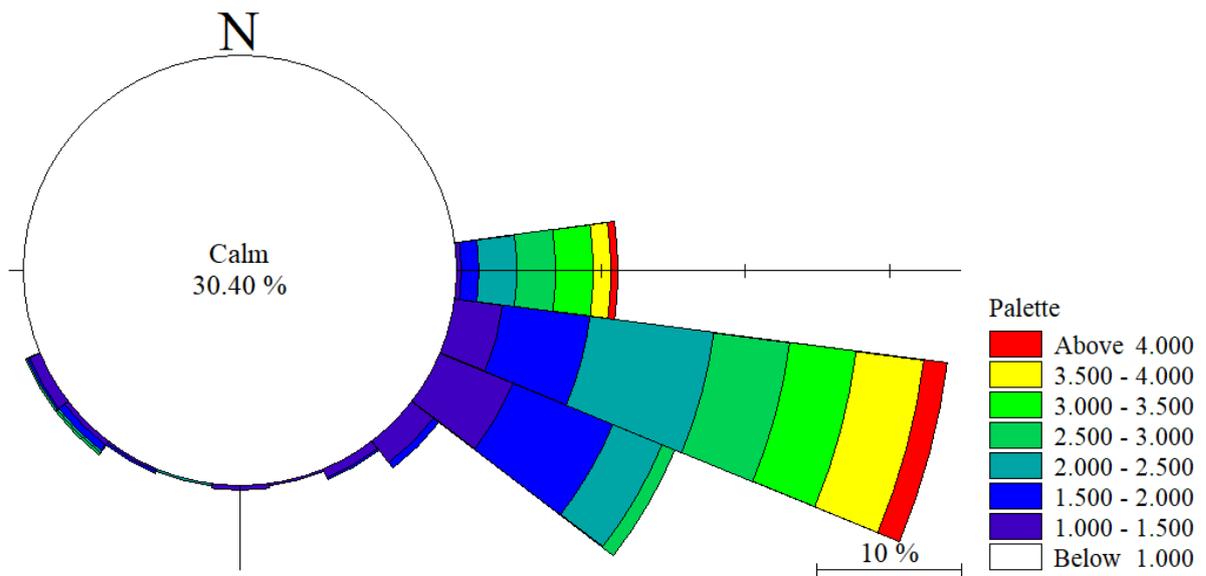
Figure 27. The wind rose in Nhat Mat from 13 to 22 August 2024

-/ Wind data is presented in Figure 27, showing that the main direction in 7-days duration is southwest with the highest velocity up to 4 m/s.

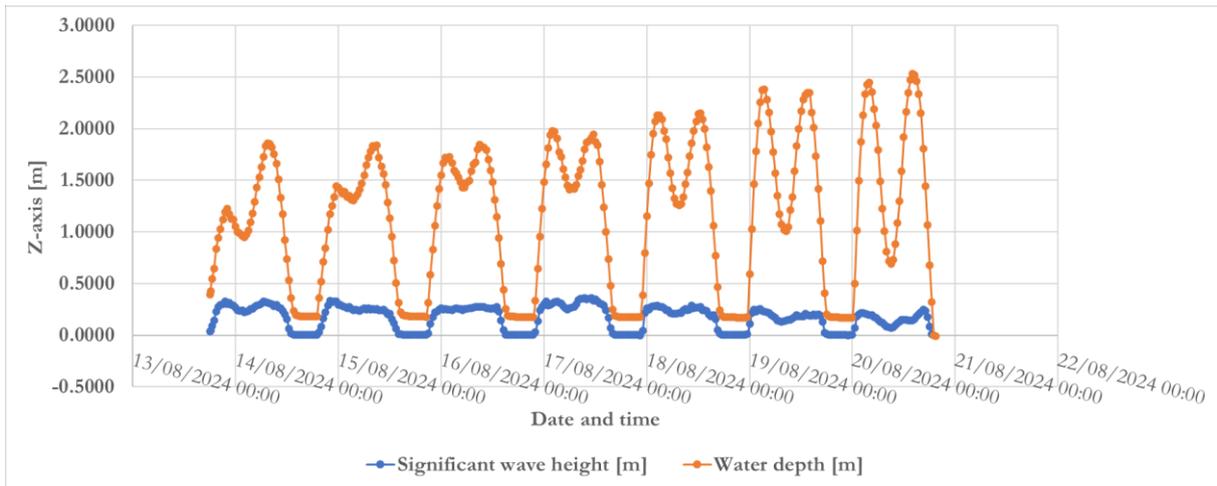
Figure 28. Significant wave heights from 12 to 22 August 2024

The significant wave heights and water depth from 12 to 22 August 2024 are shown in Figure 28. The average wave height is recorded around 0.35 m in nearly every water depth. The gentle foreshore is the cause of wave damping along the intertidal area.

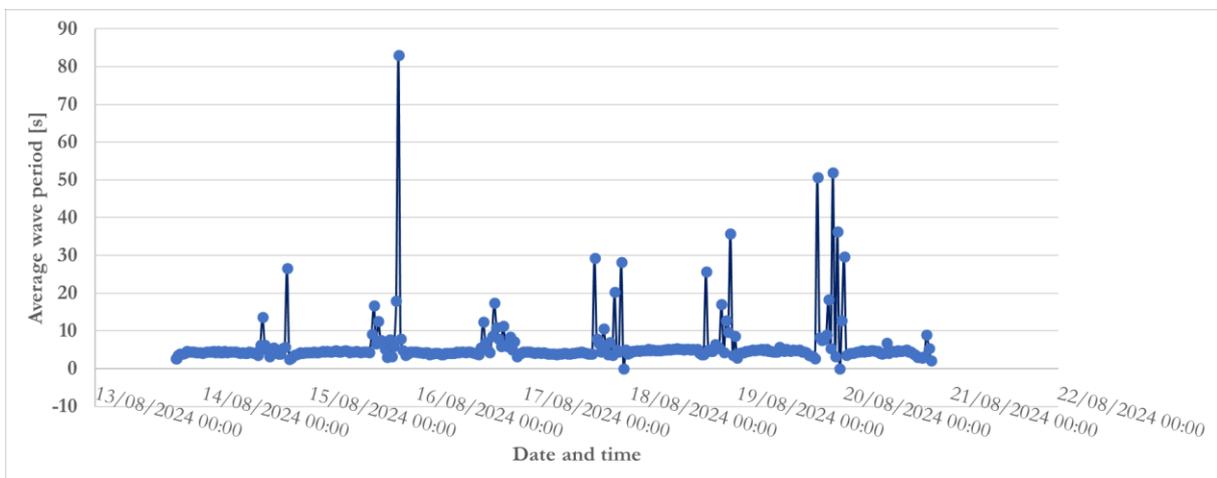
Figure 29. Averaged wave period from 12 to 22 August 2024

The average wave period shown in Figure 29 is roughly 5 seconds. There are some enormous records in the wave period that can be explained by swell waves or long waves generated by very gentle foreshore.

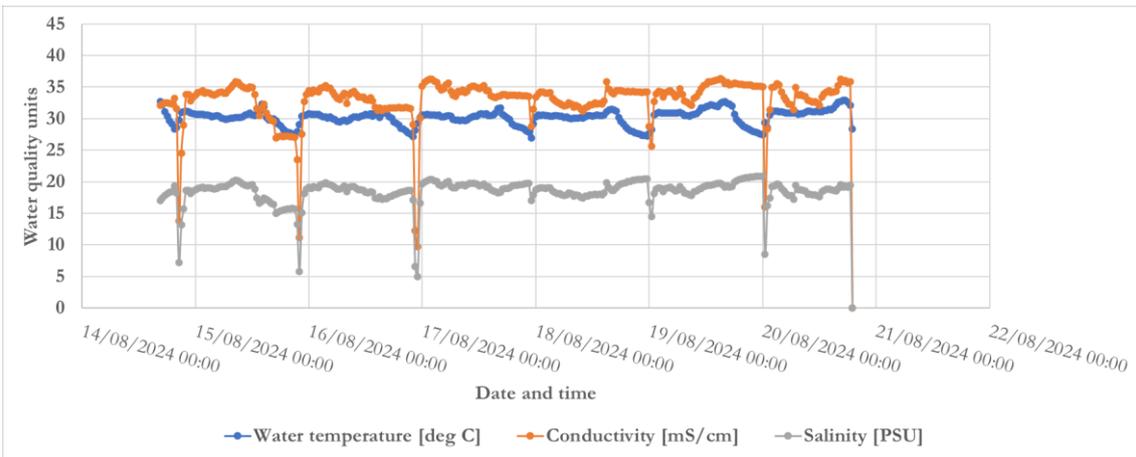
Figure 30. Water parameters from the Environmental station from 12 to 22 August 2024,

Three parameters, e.g., water temperature, conductivity, and salinity, are presented in Figure 30. It appears that salinity is quite low (22 PSU) in comparison with a common value, 35 PSU, due to river influence from the channel close by. Meanwhile, water temperature is quite high because of the influence of summer time, with an average temperature along the day reaching 35°C.

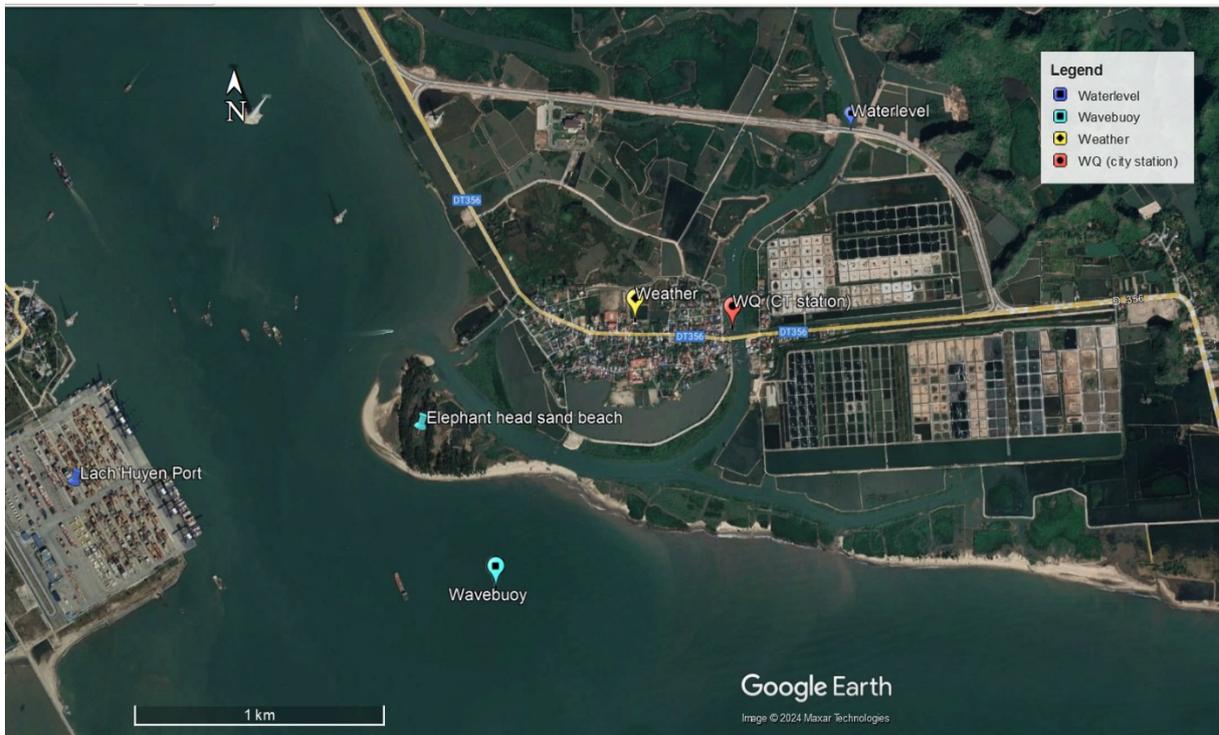
Figure 31. Designed location of Wave bouy.

Wave characteristics are obtained from only wave bouy. The location is set at 20.795600, 106.921000 (lat,lon) from 16 to 23 March 2024.

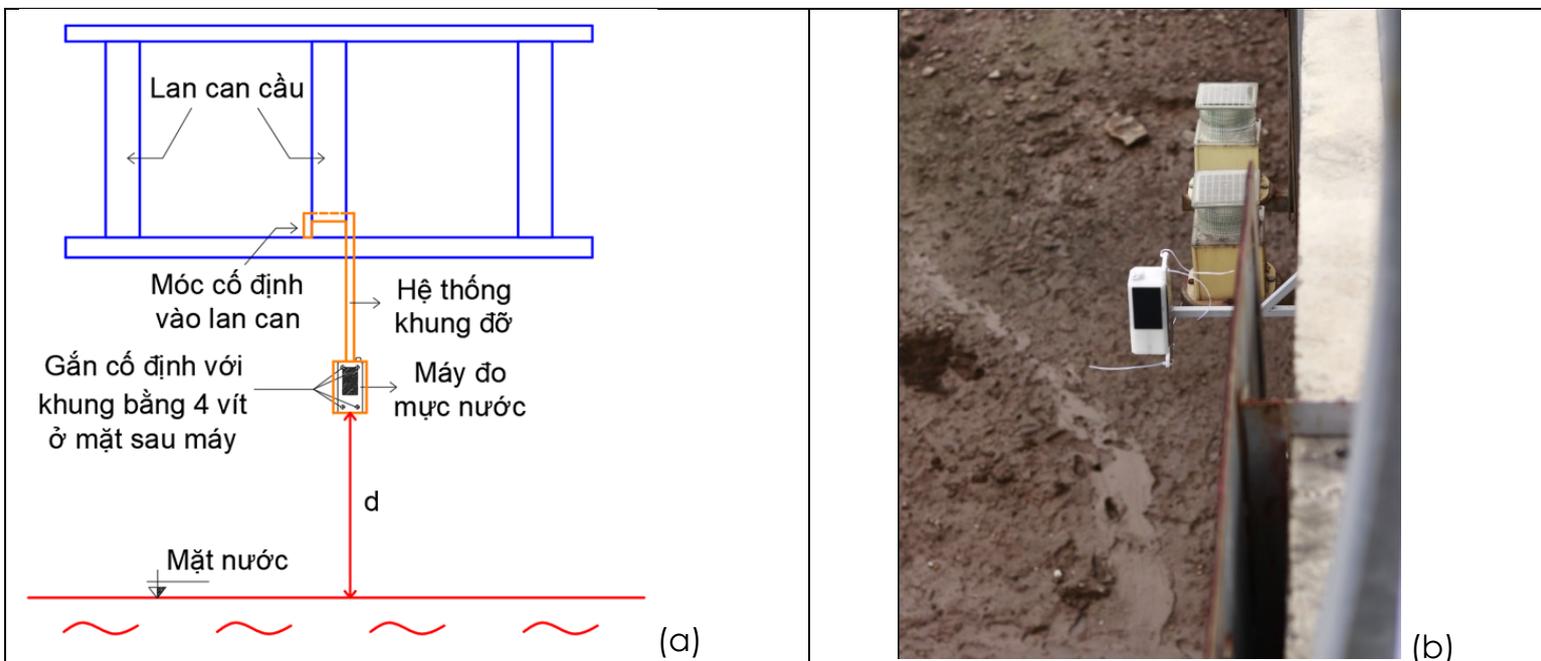
Figure 33. (a) Specific design in setting up Level gauge and (b) Level gauges after installation.

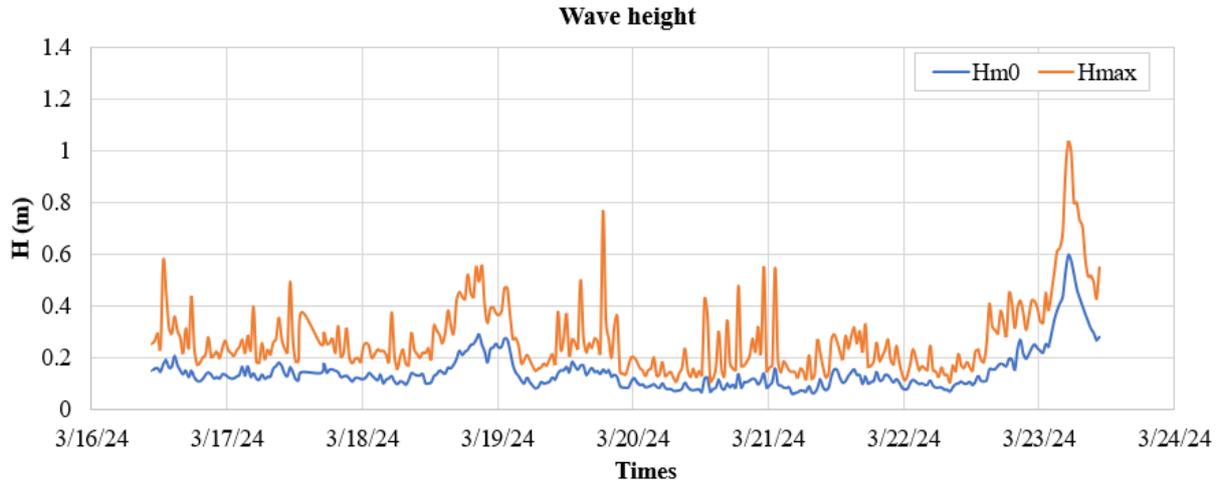
Figure 36. Significant wave height

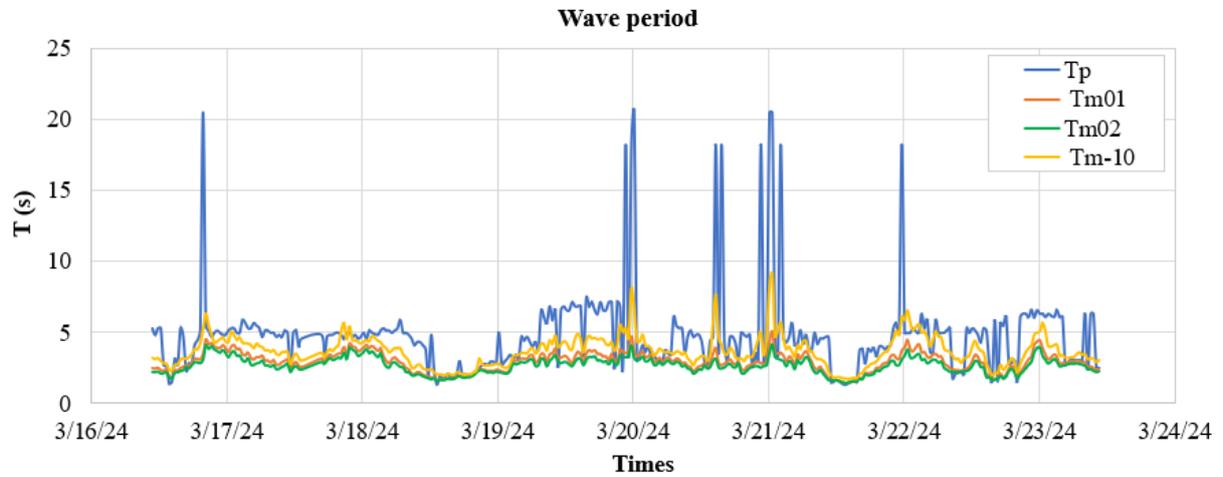
Figure 37. Wave period

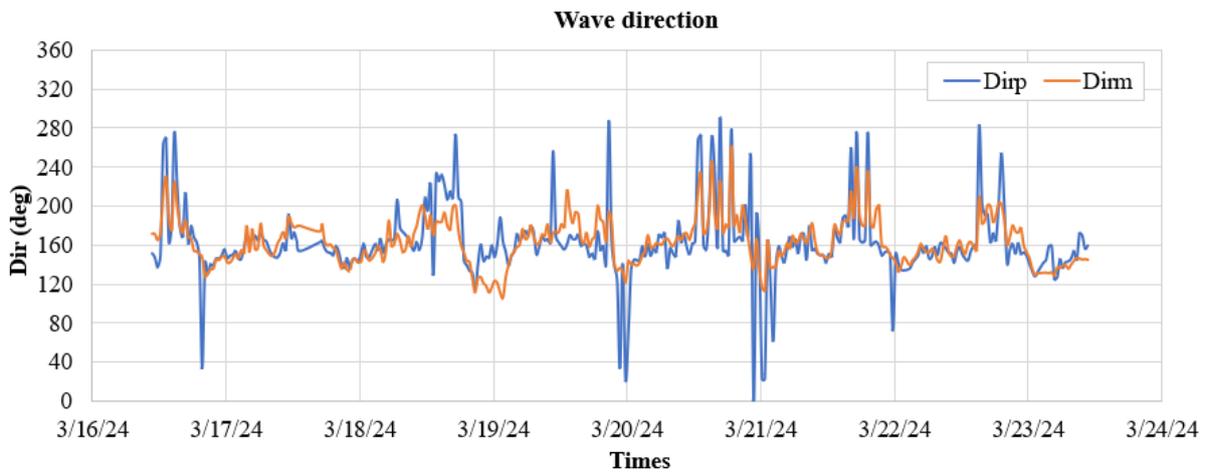
Figure 38. Wave direction

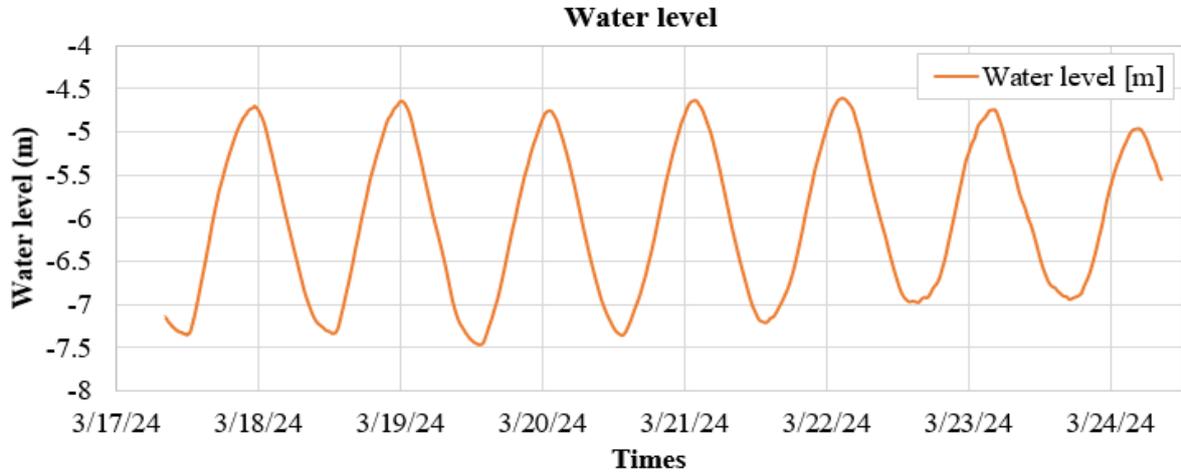
Figure 39. Water level. Note that it is needed to validate with national elevation

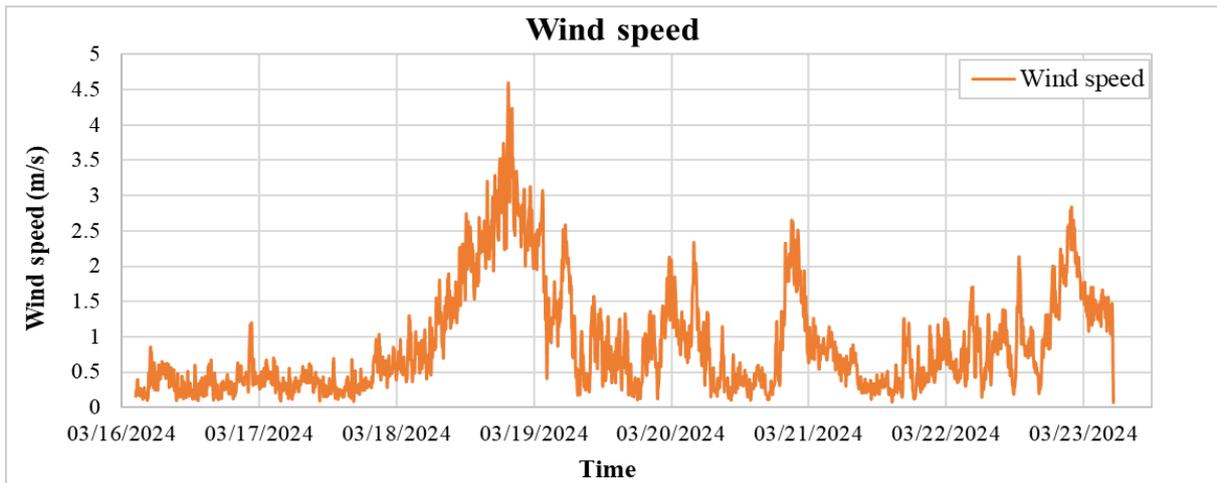
Figure 40. Wind speed
