Annual Field campaign Report

Mekong Delta Living Lab – An Open-air Laboratory for coastal protection and nature-based solutions

Vietnam, 2024

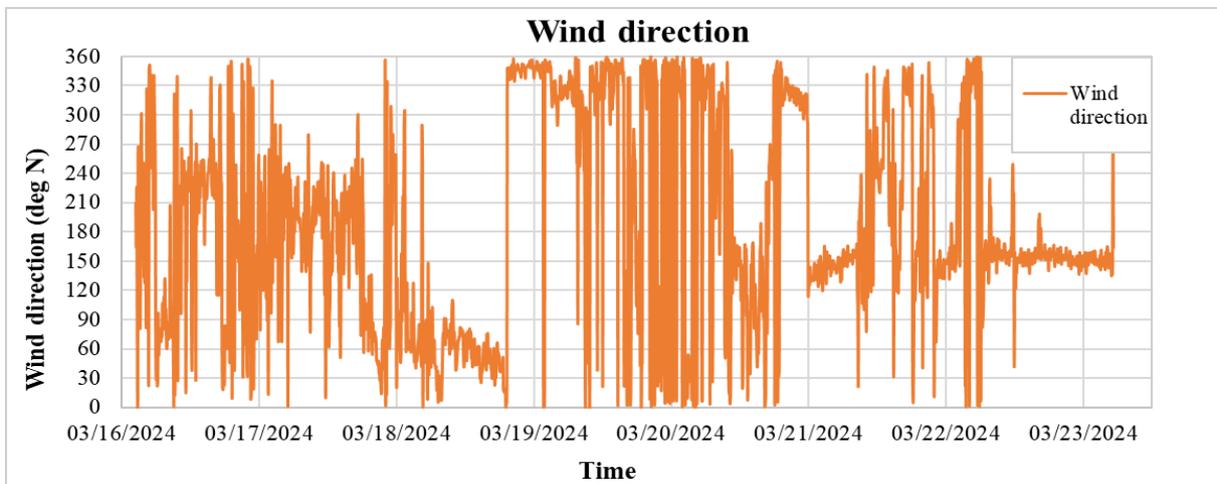
Figure 41. Wind direction

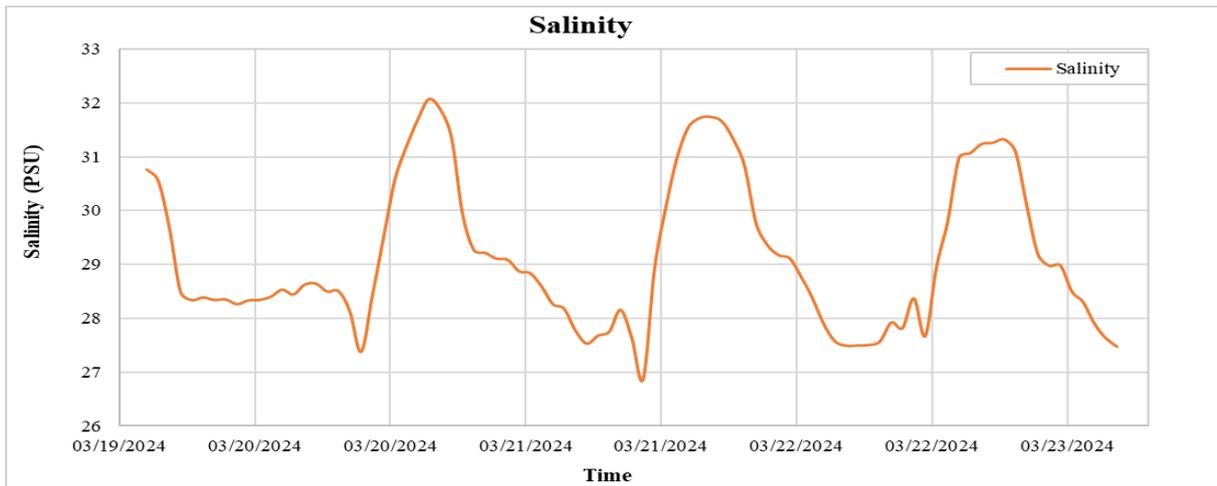
Figure 45. Salinity

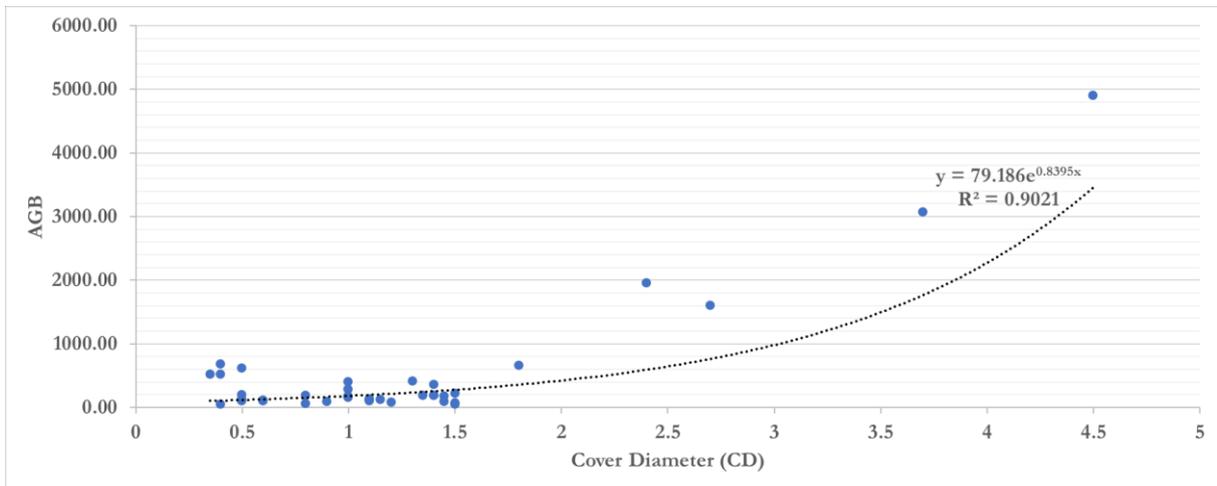
Figure 46. A relationship between Cover Diameter and AGB.

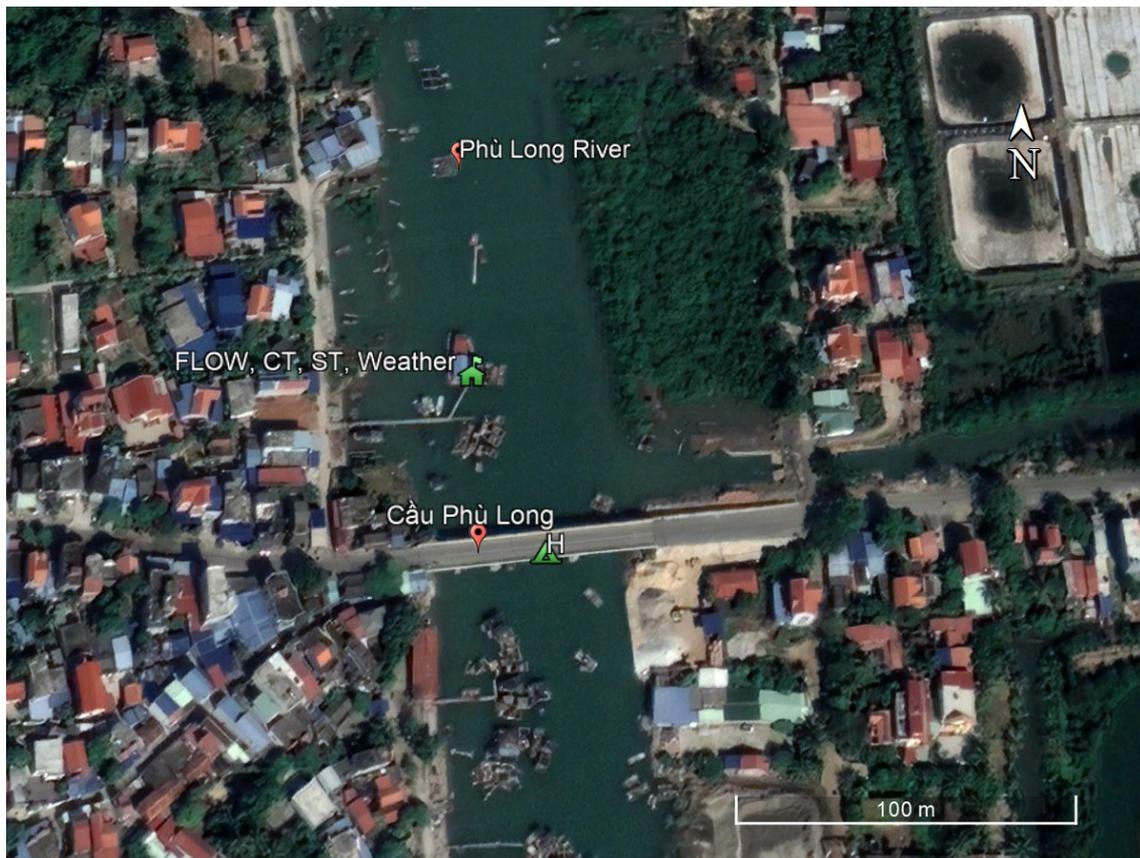
Figure 51. Locations of stations. A water Level station (elevation, H) is installed at Phu Long Bridge, while flow, water, weather, and sedimentation stations are located at a pier close by.

The second fieldwork in Phu Long took place from 27 September to 04 October 2024 to obtain particular aspects of hydrology and meteorology, e.g., flow velocity, water level (elevation records), weather, and water parameters. The measurement stations were different from the previous time, which were close to each other. Figure 51 presents the locations of each station.

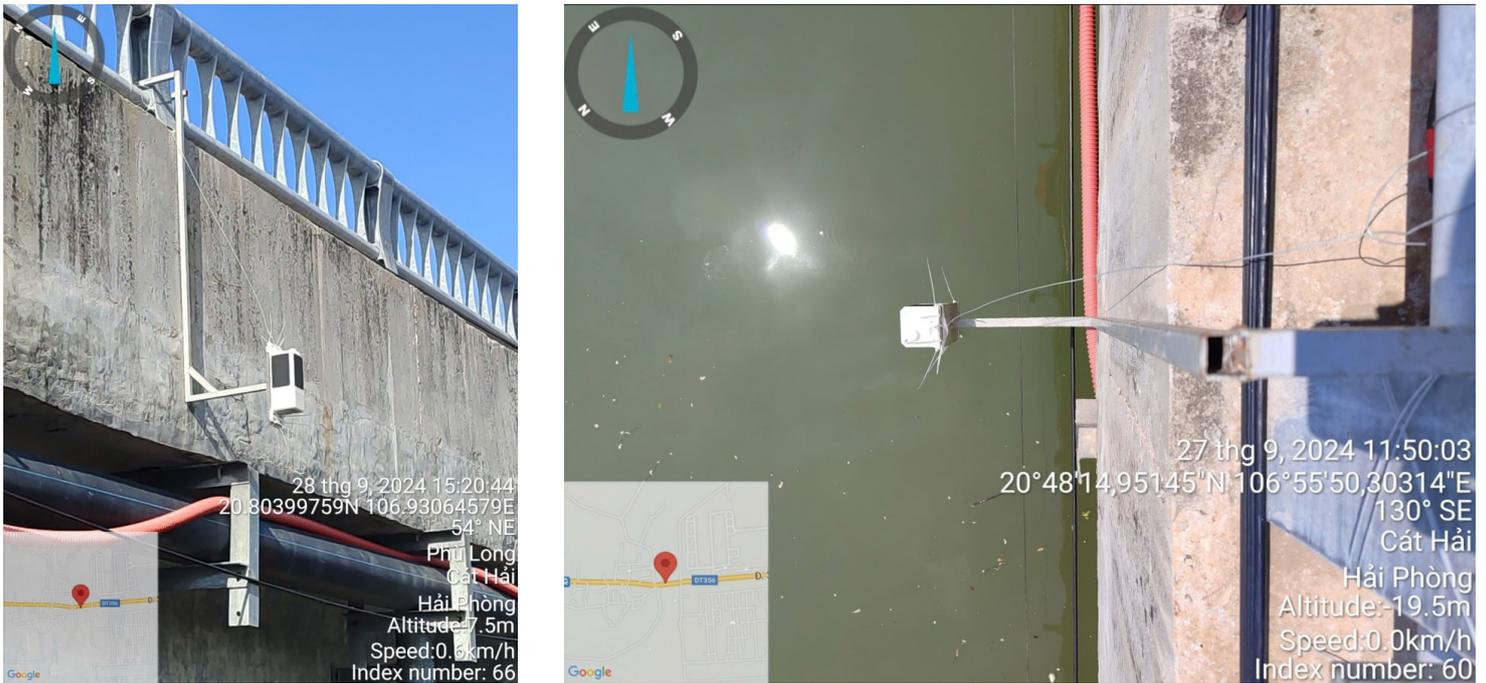
Figure 52. Level gauge devices after installation.

-/ Water level (elevation) station is installed at the sea side of the bridge (see Figure 52). Location is at 20.804063, 106.930708 (Lat, Lon). The national/global elevation is eventually obtained to validate.

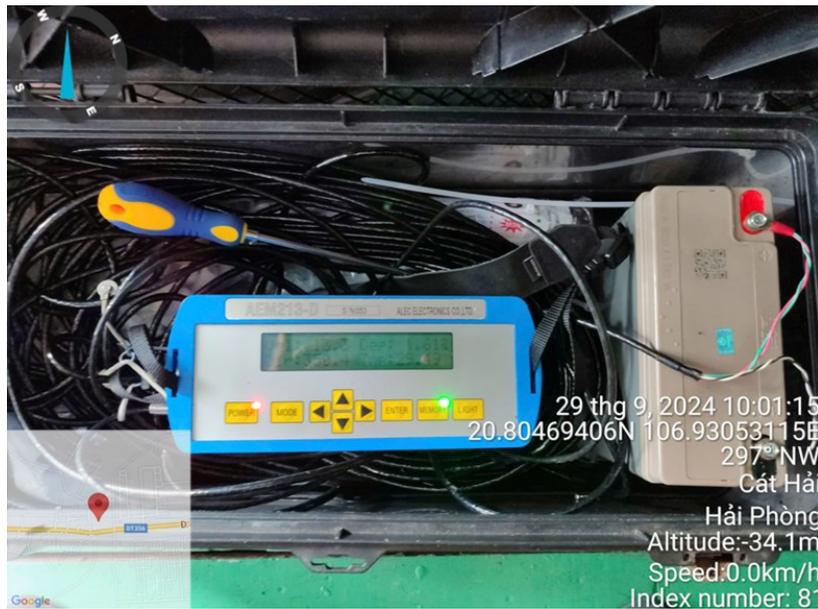
Figure 54. (a) The flow station includes a sensor put under the water surface and close to the bed (30 cm from the bed), and data records every 30 minutes with a frequency of 1/15. (b) Sedimentation collecting.

-/ Flow velocity, weather, water parameter, and sedimentation stations are all located at 20.804617, 106.930490 (Lat, Lon) shown in Figures 54 and 55.

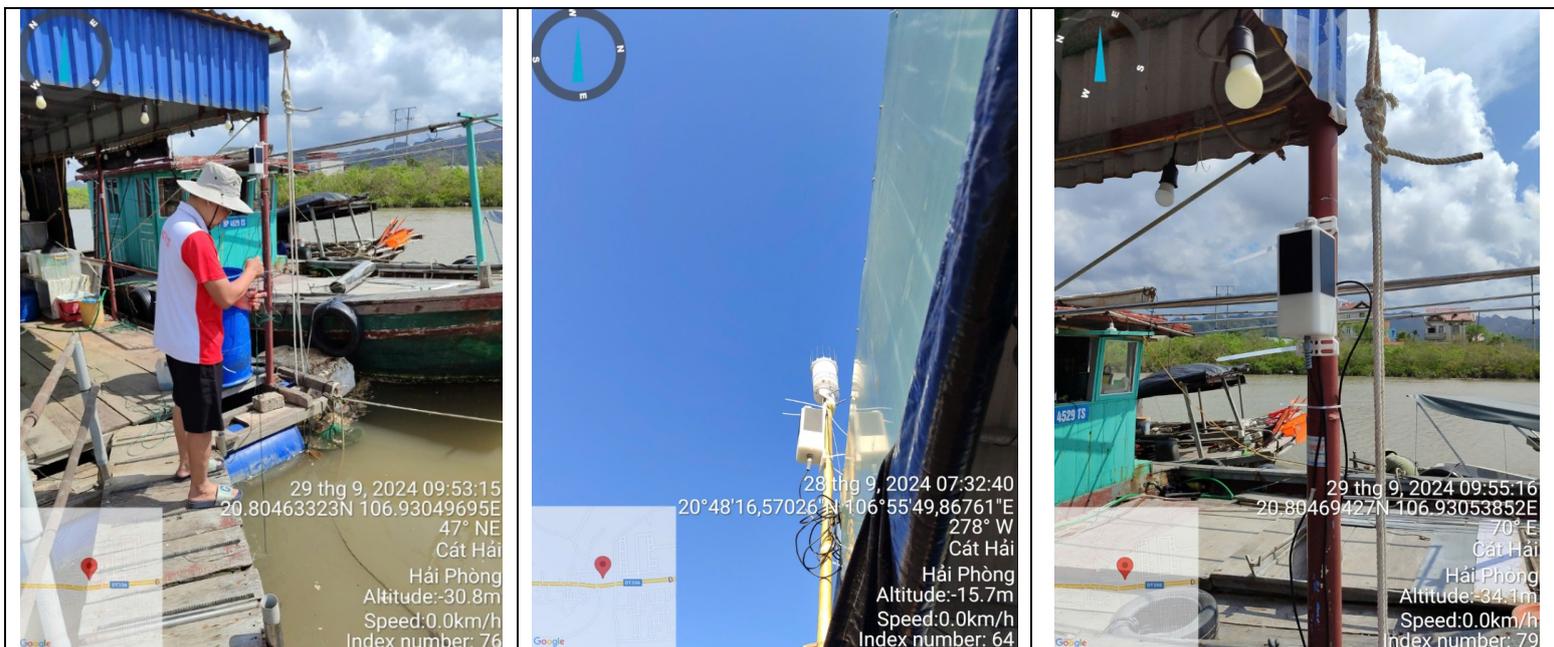
Figure 55. (a) Collecting sedimentation samples. (b) Weather station. (c) Water parameter station.

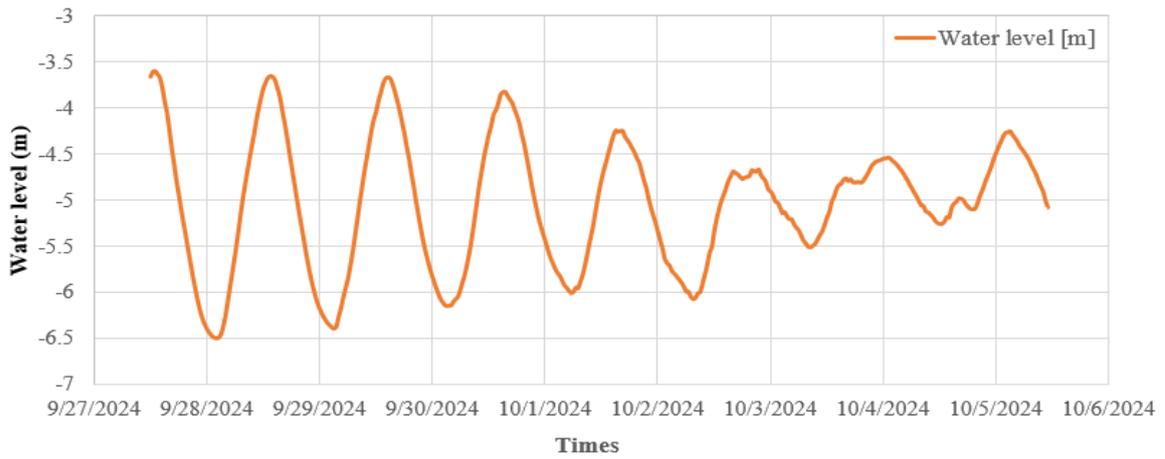
Figure 56. Elevation at the Level station

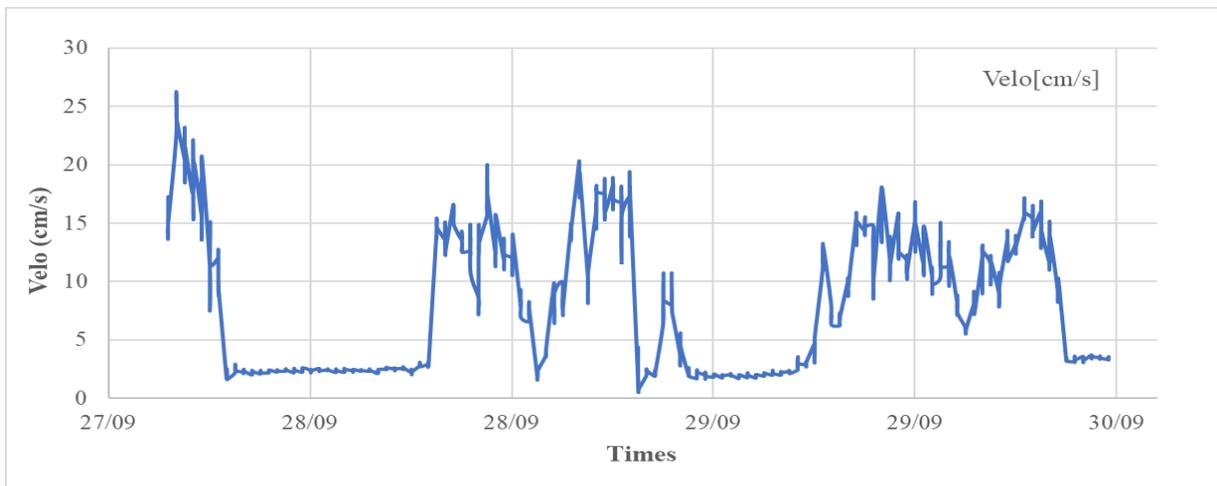
Figure 57. Flow velocity

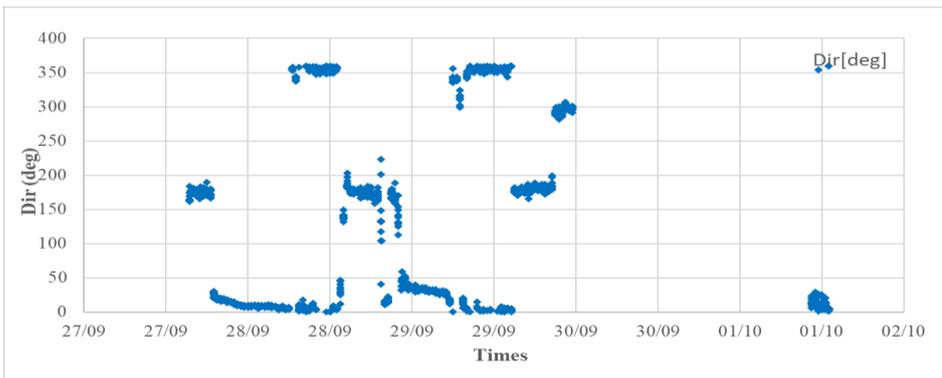
Figure 58. Flow direction

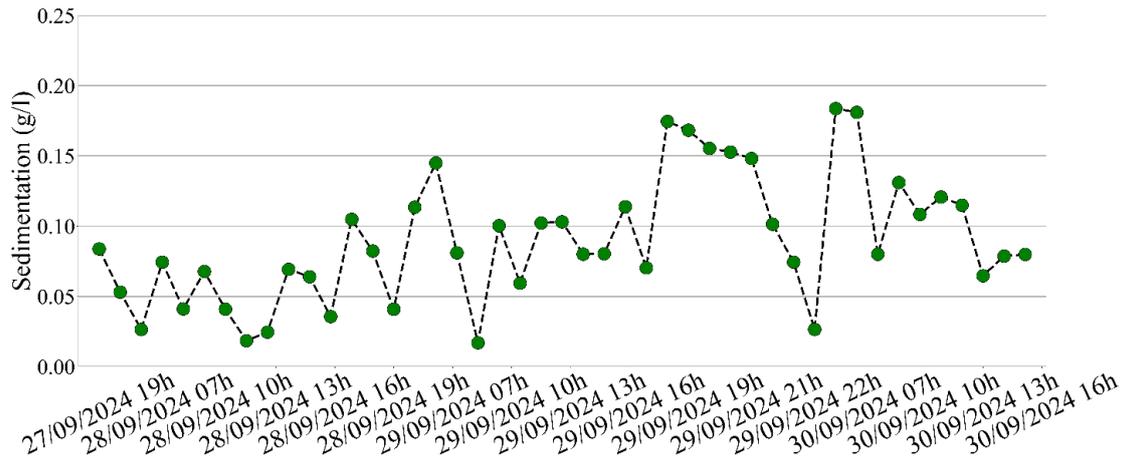
Figure 59. Final results of sedimentation during the fieldwork.

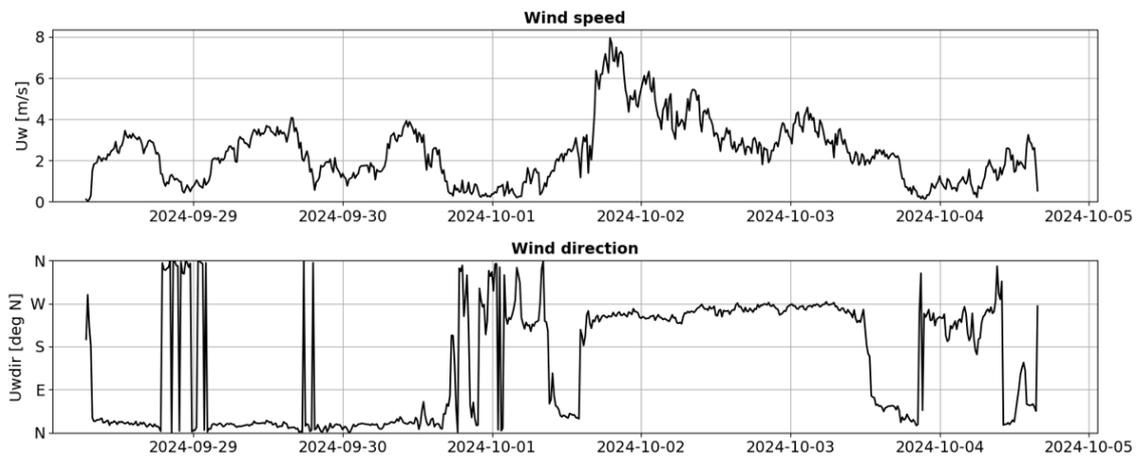
Figure 60. Wind speed and direction.

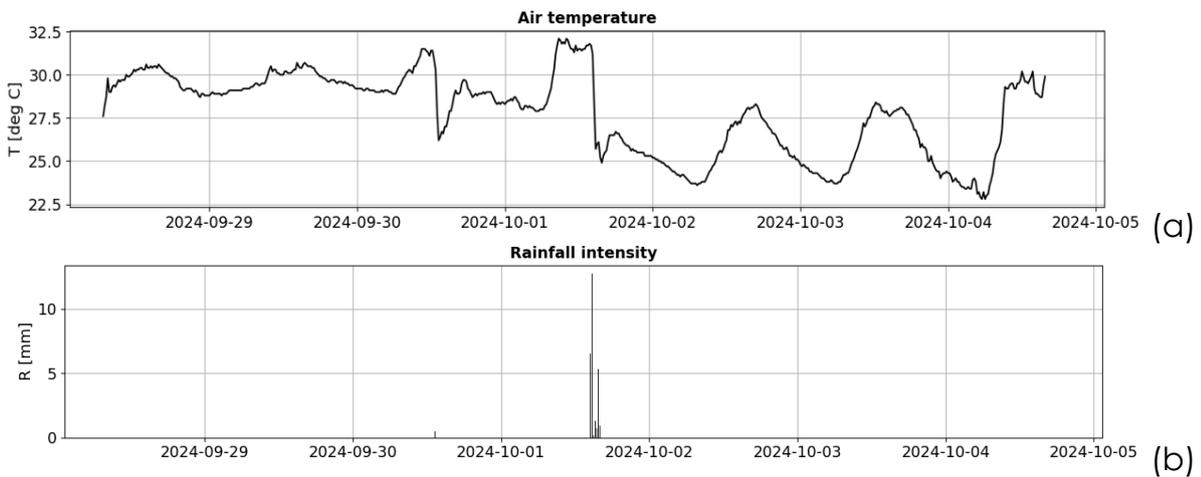
Figure 61. Air temperature (a) and rainfall intensity (b)

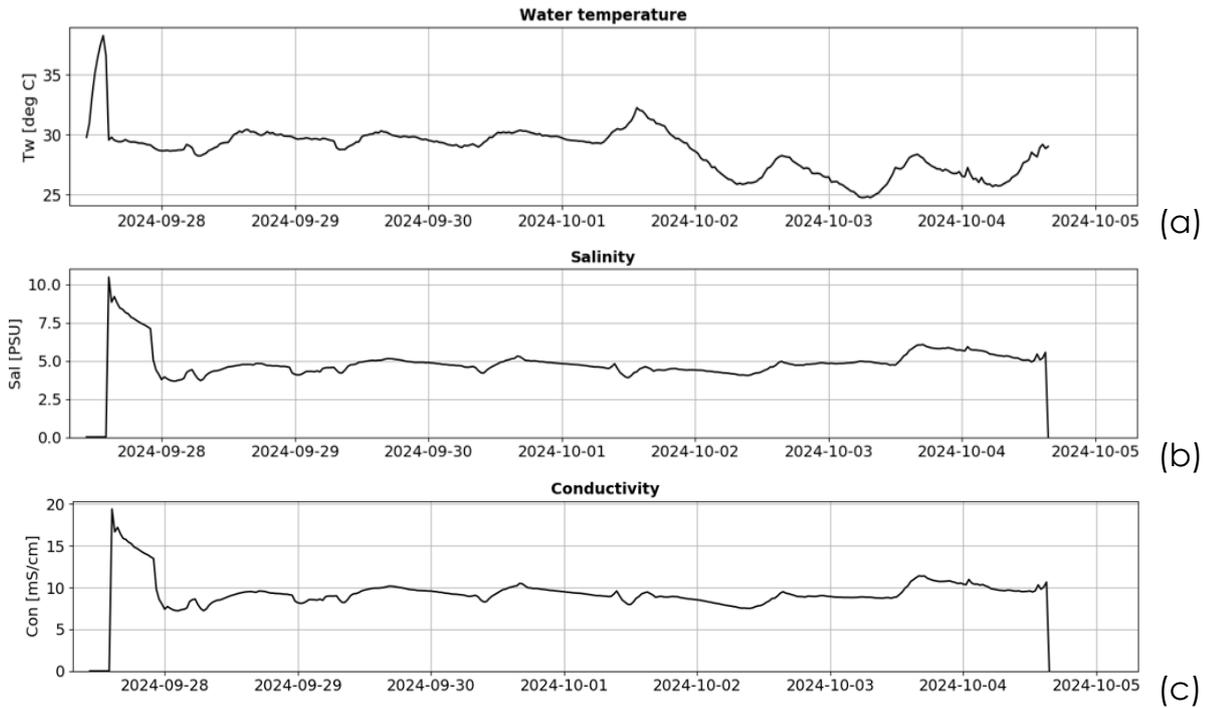
Figure 62. Water parameter from CT Station. (a) Water temperature; (b) Salinity; (c) Conductivity.
